©Kawasaki Motors Corp 1974 Printed in USA

PROBLEM:

An early H1 may start losing power, misfiring, backfiring, or stop running altogether. Installation of new spark plugs seems to clear up the problem, leaving the impression that the used plugs were defective. However, the problem returns after a short period of use with the new spark plugs.

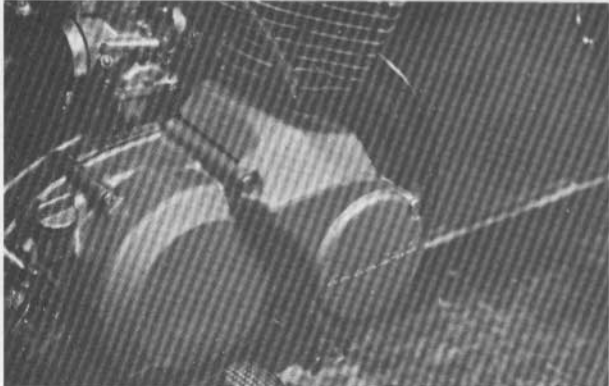
EARLY H.T. WIRING

The spark plugs generally are not the cause of the problem. We have found the high tension wiring leaks electricity to adjoining metal engine parts under high voltage loads. New spark plugs require less voltage to fire because the electrodes have sharp edges. As the plugs are used, these sharp edges are rounded off by high energy discharge and erosion from heat and chemical action in the combustion chamber. Consequently, they require an increasing amount of voltage to fire as mileage accumulates. Worn spark plugs, over-rich oil pump settings, or incorrect fuel mixtures demand more voltage from the ignition system to fire the spark plugs. These conditions "back up" the voltage in the secondary wiring until it jumps through the H.T. cord insulation to an inviting engine ground rather than fire the plugs.

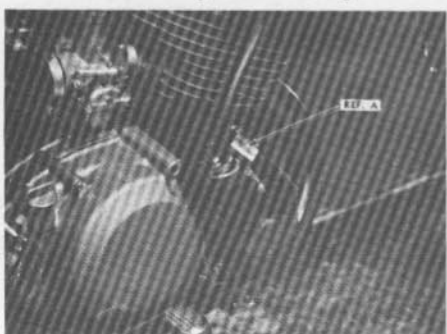
H1 with original H.T. wiring

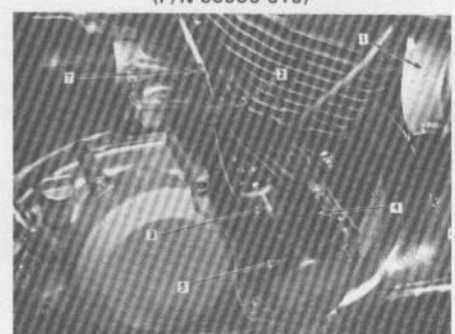
H1 with new H.T. wiring kit
(P/N 99990-015)

KAWASAKI has developed a set of high tension components which, after thorough testing, has proven completely reliable and eliminates the insulation leakage problem. The purpose of the new components is to re-route the H.T. cords so they are a safe distance from metal engine grounds like the oil pump, oil pump cover, engine cover, cylinders, carburetors, etc. Additionally, the type of H.T. cord has been changed from DAIICHI brand to Belden, a better-insulated cable.
