©Kawasaki Motors Corp 1974 Printed in USA

PROBLEM:

If the owner doesn't drive frequently, the H2 may discharge the battery. The problem has been most prevalent in cold-weather areas, where usage is limited.

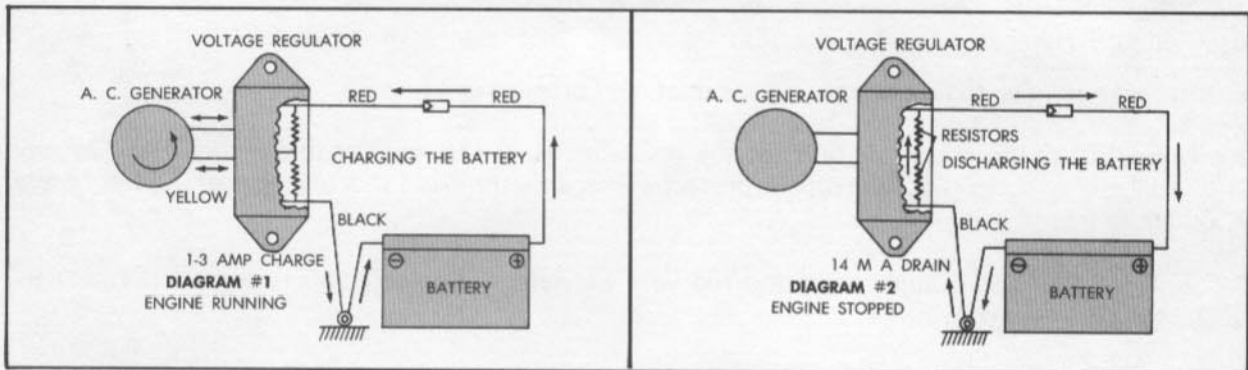
The H2 voltage regulator is connected to the battery by a red wire. This red wire carries the battery charging current when the engine is running. Because of two small resistors in the regulator circuitry, there is a slight current drain on the battery when the engine stops. In a fully charged state, it would take 2-3 weeks of inactivity for the battery to reach a serious discharge condition, because the current draw is so small (12-16 MA).
