©Kawasaki Motors Corp 1974 Printed in USA

PROBLEM:

An early H1 may start losing power, misfiring, backfiring, or stop running altogether. Installation of new spark plugs seems to clear up the problem, leaving the impression that the used plugs were defective. However, the problem returns after a short period of use with the new spark plugs.

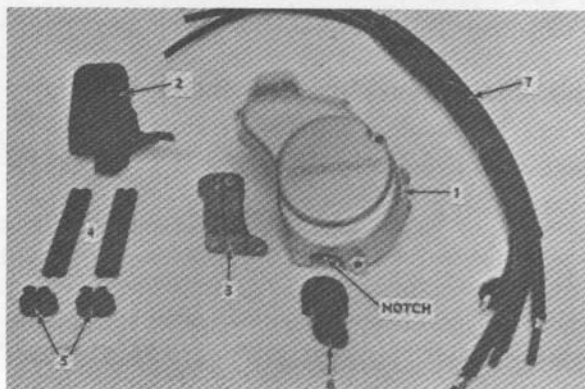
The new H.T. components were incorporated on H1's after Engine KAE-08800. The drain grommet was not used until KAE-11300, so on units from KAE-08800 to KAE-11300, the oil pump cover is not notched for the drain grommet.

If you want to convert an older H1 to all new parts, the component parts are available separately.
